Midland Service Bulletin #20111010

MIDLAND SERVICE BULLETIN

SUBJECT: Vented Ball 520-30-MO For Assembly in A-520 & A-522 Series Ball Valves

REPLACES: All 520-3-MO balls

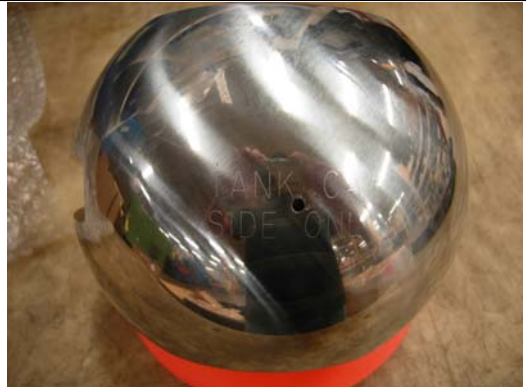
Notice marking on Ball next to vent hole
"TANK CAR SIDE ONLY"

The new vented ball (p/n 520-30-MO) **MUST BE INSTALLED WITH THE SMALL VENT HOLE POINTING TOWARDS THE TANK.**

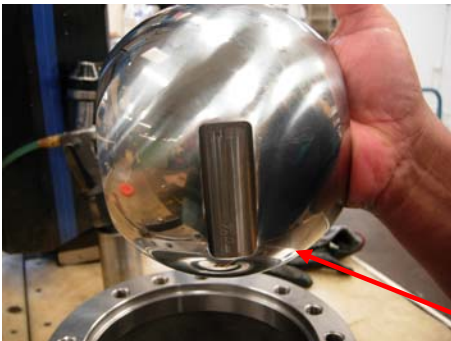
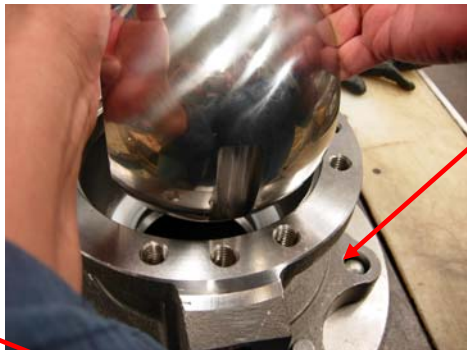
Assembly in valve body

Body flange
facing down

Marking is on bottom of Ball

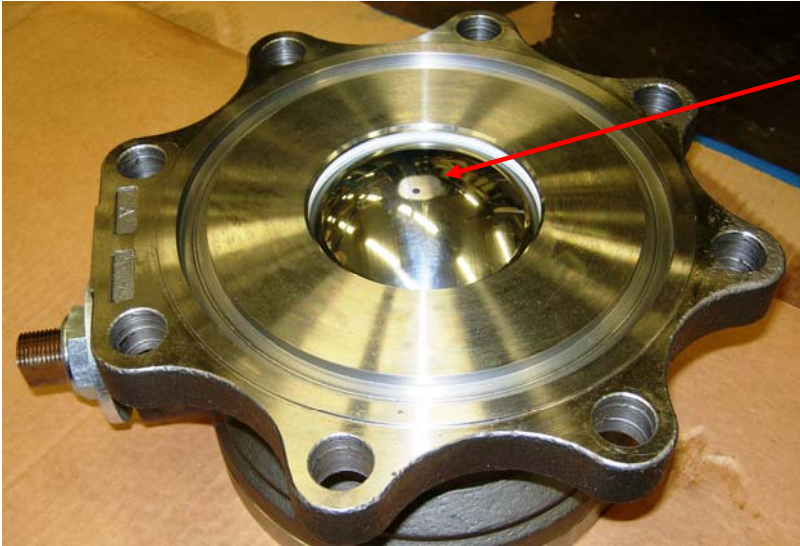
Complete valve assembly (valve closed).

Vent hole
