# **BP-Aral**, Leipzig, Germany

# BP-Aral Leipzig Upgrades to KPS Double Wall Piping to Solve Fuel Egress Issues

BP-Aral upgrades Leipzig site from steel to KPS plastic double wall piping

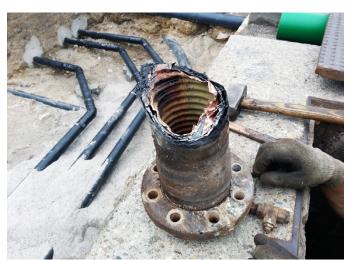
Previously installed corrugated steel and copper piping was damaged due to corrosion

The original piping had been installed over twenty years ago

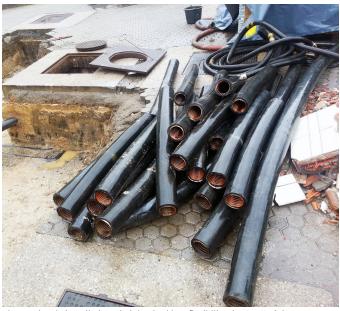
The previously installed flexible corrugated steel and copper piping had become damaged through corrosion over time, causing pipes to leak. The angle at which the concrete tank sumps had been installed required a flexible pipe replacement. Despite the challenging installation requirements, a short downtime was key to this project.

The previously installed steel piping had less flexibility than KPS piping

KPS plastic piping was installed in long curves to fit the layout of the concrete tank sumps, and a hole was cut in the corner of each sump to allow KPS termination fittings to enter, and to be connected to the tanks. KPS' double wall piping prevents leakage, while onsite training (provided by OPW) enabled a fast installation with minimal downtime.

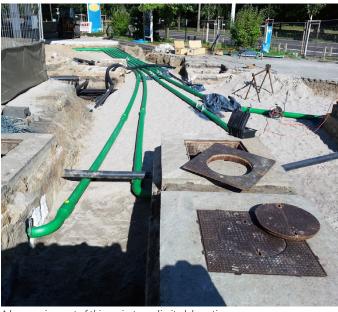
A key requirement of this project was limited downtime

A hole was cut in the corner of each sump to allow the KPS termination fittings to enter
