TEST REPORT

OPW 30 (FL76) Composite Cover BS EN124 C250 Test

Document reference number - FIB-OPW30(1)-C250-21-11-18

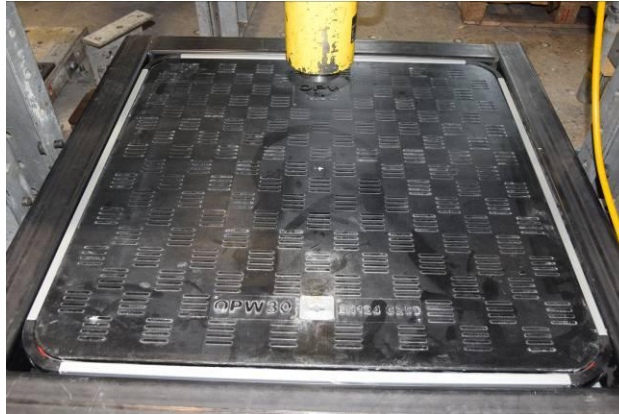
Photo. 1

The composite cover supplied is a square OPW 30 complete with aluminium frame. (Photo.1)

Cover No. : 19200

Frame No. : 18/1352

A 100mm x 100mm steel box section frame was placed around the aluminium frame to add support and as an added safety feature incase of failure.

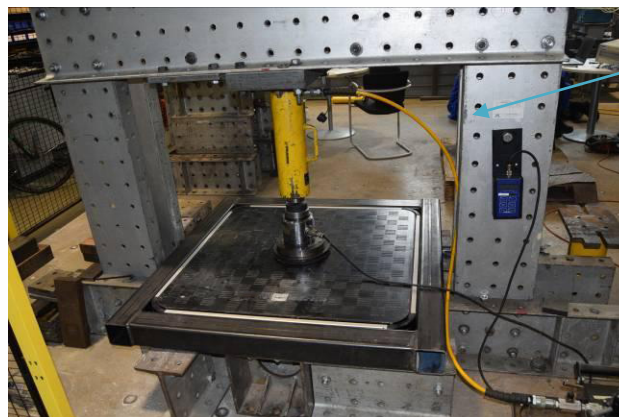
Photo.2

The test rig consists of a 'giant mecano' frame bolted to the floor and supporting the Enerpac 90 ton hydraulic cylinder. (Photo.2)

The cover was seated on steel channels with steel plates and shims to pack and level.

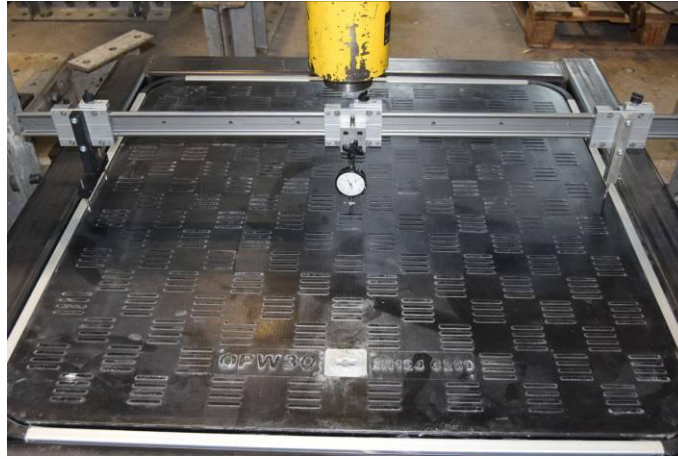
Photo.4

Initial Reading	0.00mm
Reading after 5 cycles	0.66mm
Permanent Set	0.66mm

Permissible permanent set for a C250 test is $\frac{CO}{300} = \frac{760}{300} = 2.53\text{mm}$

Therefore cover passes the permanent set test.

Measurement of permanent set shall be made on the upper-side of the cover in the same place as the applied load at the longest dimension which can be inscribed within the cover through the centre point of the load application. The measurement device shall be positioned as close as possible to the centre point of the load application and the seating of the measuring device support as close as possible to the edge of the cover but not exceeding 10mm from the edge.

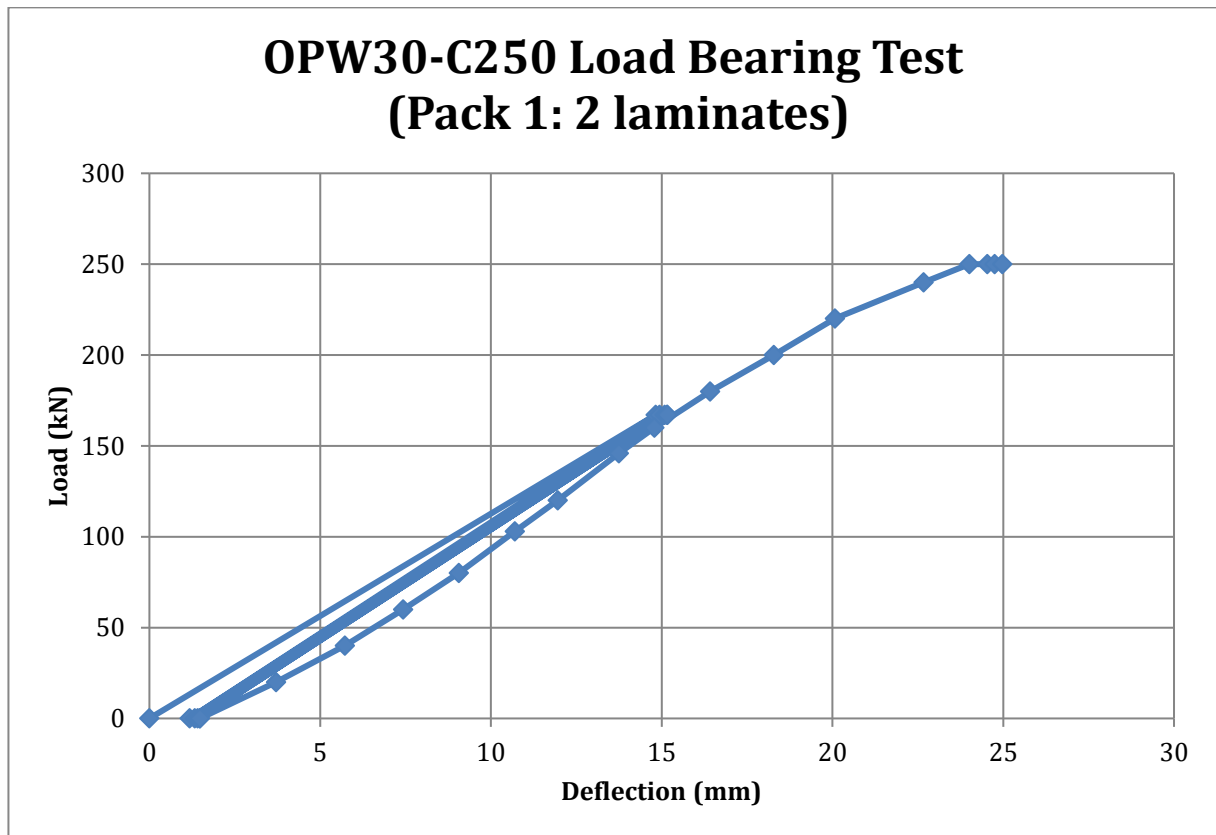
LOAD (kN)	DEFLECTION (mm)	REMARKS
0	0.00	
167	14.82	
0	1.18	
167	14.94	
0	1.33	
167	15.09	
0	1.41	
167	15.16	
0	1.48	
167	15.16	
0	1.48	
20	3.71	
40	5.72	
60	7.43	
80	9.06	
103	10.70	
120	11.96	
146	13.75	
160	14.79	
180	16.42	
200	18.28	
220	20.07	
240	22.67	
250	24.01	
250 (10 seconds)	24.53	
250 (20 seconds)	24.75	
250 (30 seconds)	24.97	PASS

The cover reached the test load of 250kN and held that load for the required 30 seconds so therefore passed the EN 124 C250 Load Bearing test.

The slight difference noted between the true permanent set reading taken on the top face and that of the zero readings taken on the underside, can be explained by the fact that the underside readings show the result of the cover bedding into the frame.

There were no signs of any visible damage to the frame.
