# TEST REPORT

## OPW 35 Composite Cover BS EN124 C250 Test

Document reference number - FIB-OPW35-C250-12-06-19

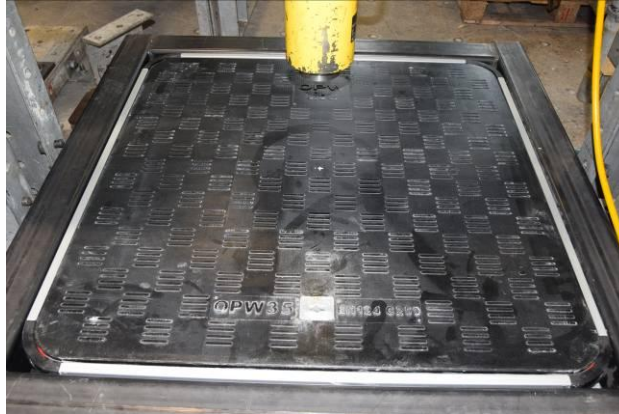
Photo. 1

The composite cover supplied is a square OPW 35 complete with aluminium frame. (Photo.1)

**Cover No. : 9664**

A 100mm x 100mm steel box section frame was placed around the aluminium frame to add support and as an added safety feature incase of failure.

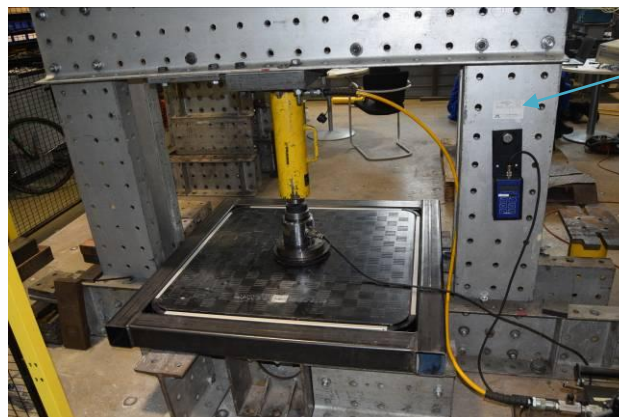
Photo.2

The test rig consists of a 'giant mecano' frame bolted to the floor and supporting the Enerpac 50 ton hydraulic cylinder. (Photo.2)

The cover was seated on steel channels with steel plates and shims to pack and level.

In accordance with the EN124-1:2015 standard the load cell and test rig complies with EN ISO 7500-1:2004 minimum Class 3.

Test Rig ID: EG100TF

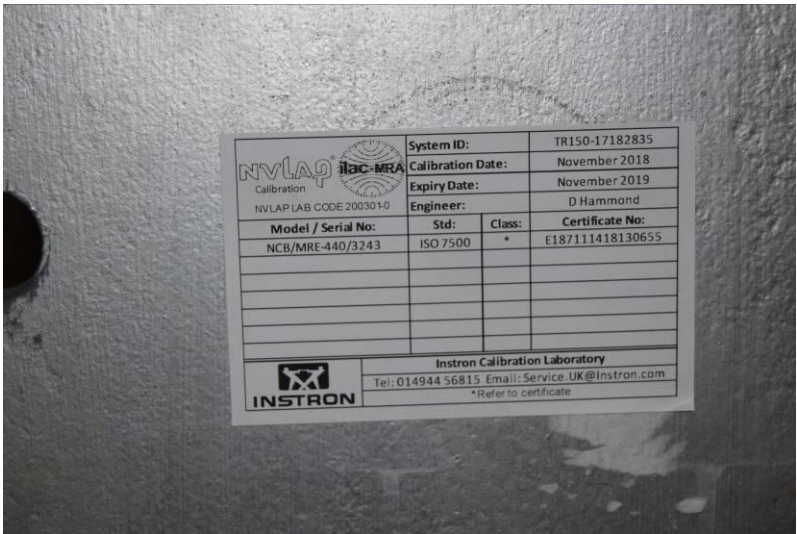
Photo.3

Photograph 3 below shows the calibration certificate for the load cell and test rig.

Instron Calibration Certificate No. E225112816155035

System Class: 2

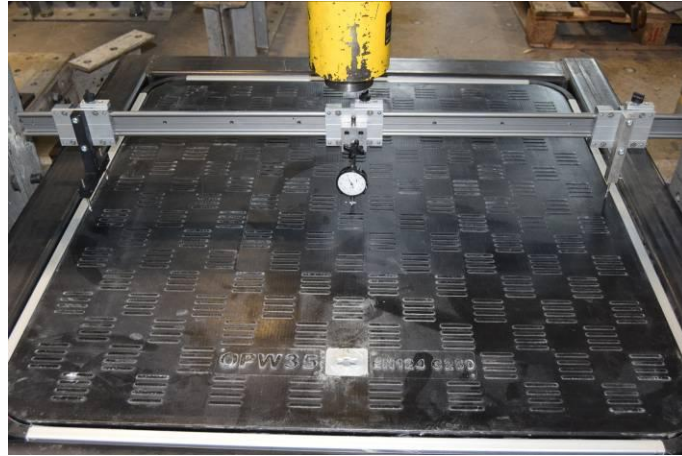
Photo.4

Initial Reading	0.00mm
Reading after 5 cycles	0.56mm
<b>Permanent Set</b>	<b>0.56mm</b>

Permissible permanent set for a C250 test is  $\frac{1000}{300} = 3.33\text{mm}$

**Therefore cover passes the permanent set test.**

Measurement of permanent set shall be made on the upper-side of the cover in the same place as the applied load at the longest dimension which can be inscribed within the cover through the centre point of the load application. The measurement device shall be positioned as close as possible to the centre point of the load application and the seating of the measuring device support as close as possible to the edge of the cover but not exceeding 10mm from the edge.

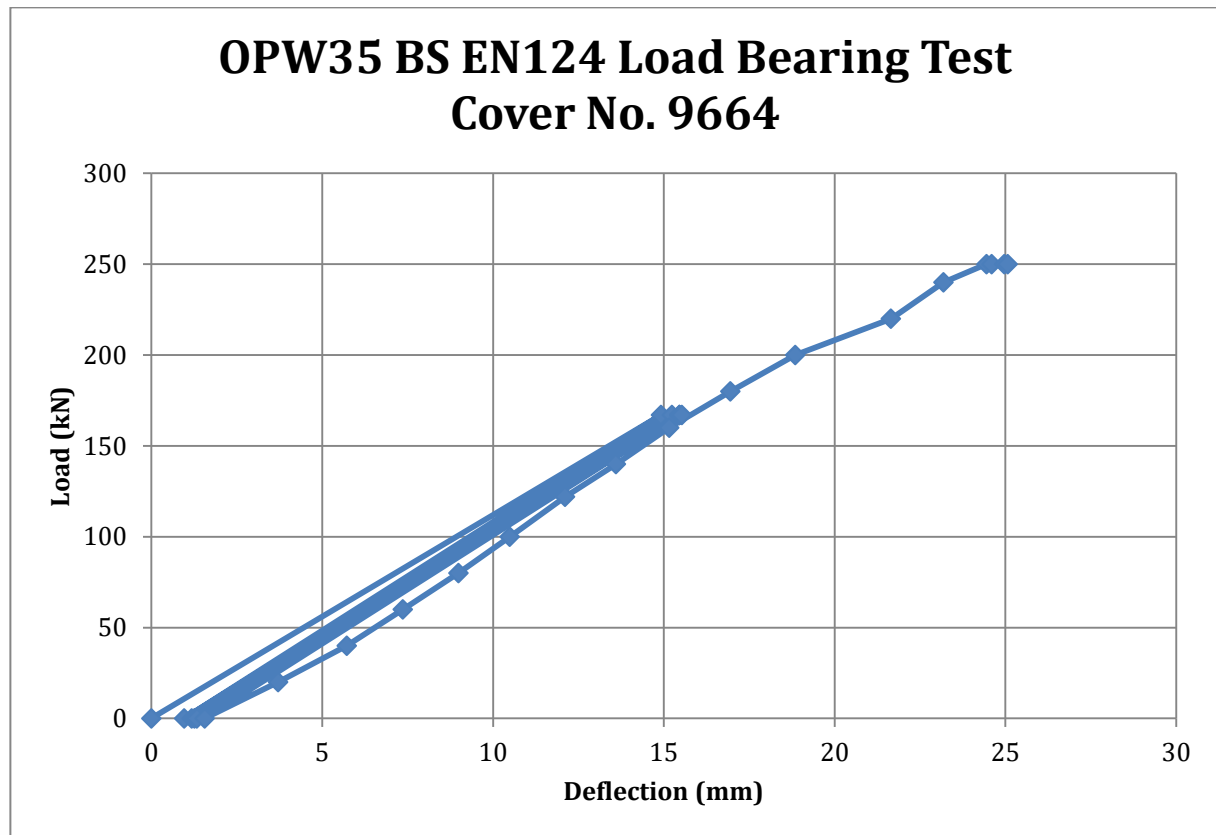
**The cover held the test load of 250kN for the required 30 seconds with no visible signs of damage so therefore passed the BS EN 124 C250 Load Bearing test.**

There were no signs of any visible damage to the frame.

LOAD (kN)	DEFLECTION (mm)	REMARKS
0	0.00	
167	14.92	
0	0.96	
167	15.24	
0	1.18	
167	15.46	
0	1.26	
167	15.46	
0	1.33	
167	15.53	
0	1.56	
20	3.71	
40	5.72	
60	7.36	
80	8.99	
100	10.49	
122	12.11	
140	13.60	
160	15.16	
180	16.95	
200	18.85	
220	21.65	
240	23.19	
250	24.45	
250 (10 seconds)	24.60	
250 (20 seconds)	24.97	
250 (30 seconds)	25.07	<b>PASS</b>
