EDGE™ SPILL CONTAINER TROUBLESHOOTING GUIDE

CAUSES OF COMMON SPILL BUCKET
MAINTENANCE ISSUES AND HOW TO ADDRESS THEM

SMARTER SPILL BUCKET TROUBLESHOOTING

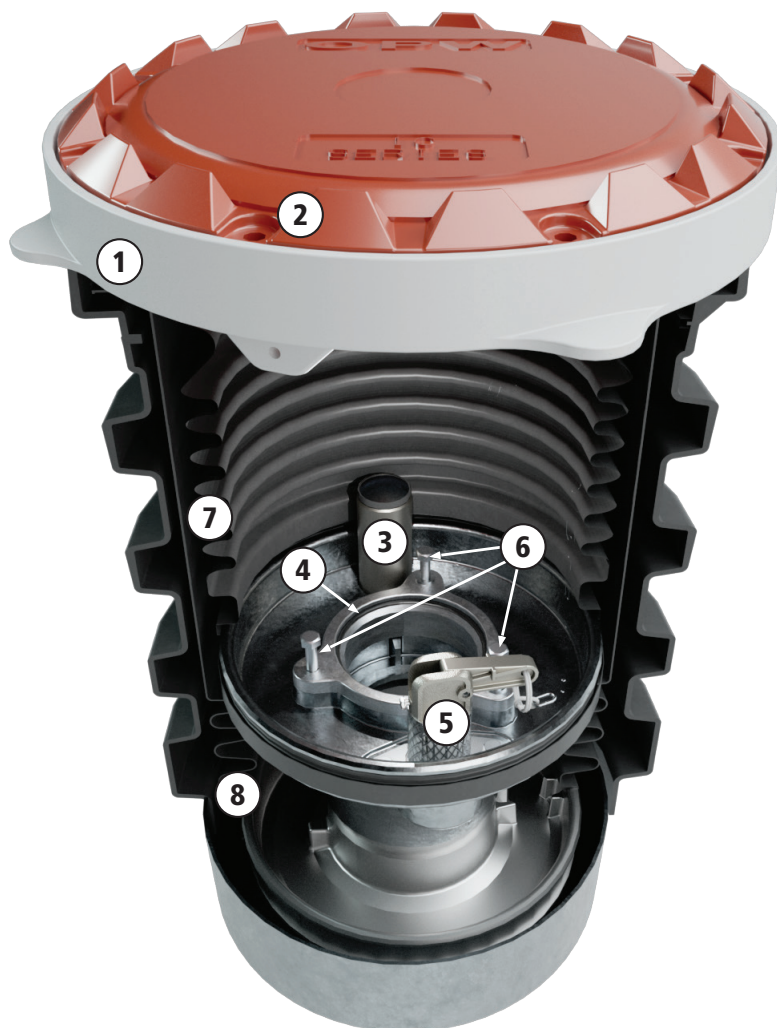
Containment Part Numbers:

- 1** 201689 – 5-Gallon Seal for Snow-Plow Ring
C05446M – 15 Gallon Seal
- 2** 1-31RTR 5-Gallon Rain-Tight Snow-Plow Ring
For sealable cover rings, please see the catalog for powder-coated rings.
- 3** 211465 – Complete Visigauge Assembly
(all parts & O-rings)
206017 – Sensor Adapter Assembly
(poly plug with O-ring)
See the catalog for individual component part numbers,
i.e., O-rings, gauge only, etc.
- 4** 201739 – 3-Bolt Flange/Nipple adapter
201692 – O-ring for 3-Bolt Flange/Nipple adapter
- 5** 1DK-2100-EVR – Drain-Valve Subassembly
1DP-2100 – Plug Kit
- 6** 201970 – 3/8-16 x 1.5" SST Bolt
200254 – 3/8" SST Lock Washer

5-Gallon Buckets **Primary** Containment Replacement Kit

- 7** 202135-KIT – Models with a Drain
202136-KIT – Models with a Plug

5-Gallon Buckets **Secondary** Containment Replacement Kit

- 8** 202137-KIT – Models with a Visual Gauge
206010-KIT – Models with Access Port
(no gauge or sensor)
206011-KIT – Models with Electronic Sensor

Please refer to the back page of this brochure for a diagram of an OPW EDGE™ Double Wall Spill Container that illustrates where to begin investigating a potential problem.

RECOMMENDED PATH/POSSIBLE CAUSE	WHERE TO LOOK/WHAT TO CHECK
The plow ring is the most common leak path because the ring feels the force and weight of every car that drives over it. Fortunately, the repair is quick and inexpensive. To determine if there is a leak, add 1/2 PSI pressure to the interstice, spray with a soap mixture and watch for bubbles.	First, check the torque on the plow ring bolts to ensure they are torqued to 20 ft-lbs. It is OK to torque these up to 25 ft-lbs. Ensure all bolts are torqued to the same value. If the vacuum leak persists from the top ring, replace the gaskets. Inspection Location: 1 (See Back Page)
The next most common issue is a broken or loose O-ring on a Visigauge or Sensor Adapter (white plug).	All OPW Double Wall EDGE™ Spill Containers have a Visigauge, Access Port, or Sensor Adapter in the primary. Remove this plug to ensure the O-rings are in good condition. Depending on the style of the spill bucket, components are available to replace O-rings, Sensor Adapters and Visigauges. OPW also offers these parts as complete assemblies. If the Drain Plug is resistant to removal and reinstallation, a new white adapter/gauge adapter may be necessary. Inspection Location: 3 (See Back Page)

Compromised containment bellows could be the issue or, less frequently, a compromised base seal is possible. This area of the container is not accessible for component replacements, but a replacement cartridge is available to satisfy either scenario. These failures typically cause a very quick loss of vacuum.	Compromised primary bellows can usually be seen from grade during a thorough inspection. If there are no signs of issues after checking the ring seals and gauge port, disassemble the spill bucket further to identify the source of the leak path. Inspection Location: 7 (See Back Page)

RECOMMENDED PATH/POSSIBLE CAUSE	WHERE TO LOOK/WHAT TO CHECK
Liquid found in the interstice means either groundwater is leaking in, or fuel/residual water is leaking out of the primary.	First, determine if the liquid is fuel or water. If the liquid is fuel, it is coming from inside the primary. Look there for possible paths. Water, however, can come from either the inside or the outside. Look for any possible signs of damage on the ring, primary bellows, or Visigauge/Sensor Adapter. Check for any missing or loose hardware. Inspection Location: 1, 2, 3 (See Back Page)
If seals are in good shape, bolts are tight and the Visigauge/Sensor Adapter is in good shape and tight, remove the primary cartridge to inspect the secondary. When the primary is removed, check the bellows seal (not replaceable) around the base. Clean and condition the seals within, and where the secondary base threads into the primary base.	When removing the primary cartridge, inspect the O-ring that seals the primary base to the secondary base. If no components are identified as the cause of the leak, consider installing new assemblies to return the spill container to a like-new condition. See chart on following page for containment part numbers by model. Note: A sensed spill bucket will contain a passthrough location for the sensor wire. Inspect this area of the container when the primary is removed. Inspection Location: 7, 8 (See Back Page)

RECOMMENDED PATH/POSSIBLE CAUSE	WHERE TO LOOK/WHAT TO CHECK
Hydrostatic test failures indicate a path exists somewhere from the primary into the secondary or into the tank via the drain/plug, 3-bolt flange or nipple assembly.	If the spill container fails a hydrostatic test, observe the area where the water level dropped, if possible. Investigate the drain/plug assemblies for any damage, movement or loose hardware. Check the Visigauge/Sensor Adapter plug and O-ring to ensure good condition. Be sure the 3-bolt flange is tight. Check the fill adapter and nipple assembly for pitting or poor connections. If issues cannot be found in these areas, consider removing the primary to inspect it further or replace it. Inspection Location: 3, 4, 5, 6 (See Back Page)
Drop tube/drain valve pressure test failures sometimes result from a problem in the spill bucket area.	Investigate the drain valve/plug area. Inspection Location: 5 (See Back Page)
