Series ALVN Manhole Cover User Maintenance and Testing Manual

Product Description

The Civacon ALVN Series Manhole Cover is designed for use on Petroleum Cargo Tanks that must meet U.S. Department of Transportation 49 CFR 178.345-10 and 178.346-3 requirements for DOT 406 emergency venting and 49 CFR 178.345-5 for manhole strength requirements.

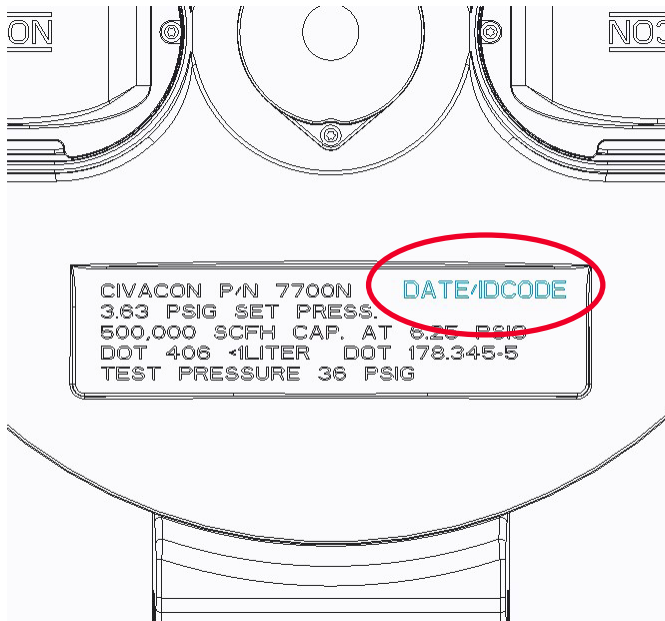
The Civacon ALVN Series Manhole Cover with the 7700N Series PAF Vent may be identified as follows:

DATE CODE AND ASSEMBLY CODE
WILL BE PERMANENTLY MARKED
IN THIS AREA.

This Maintenance Manual applies only to the Civacon ALVN Series Manhole with the 7700N Series PAF Vent. If the manhole does not have the above-mentioned markings, this manual may not be used. Please contact Civacon for information on other maintenance manuals available for earlier products.

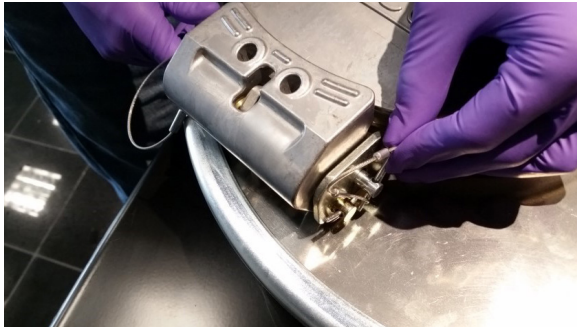
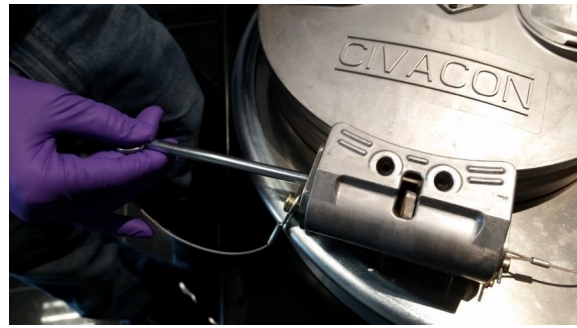
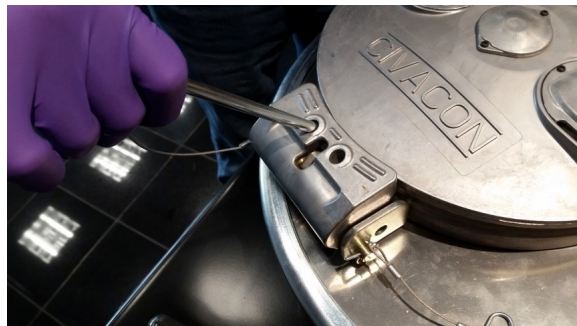
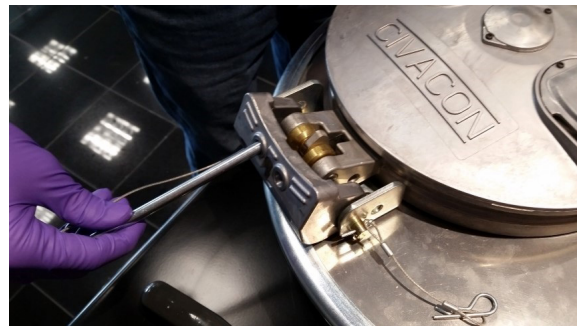
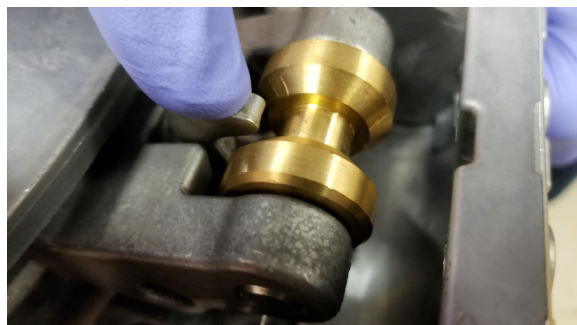
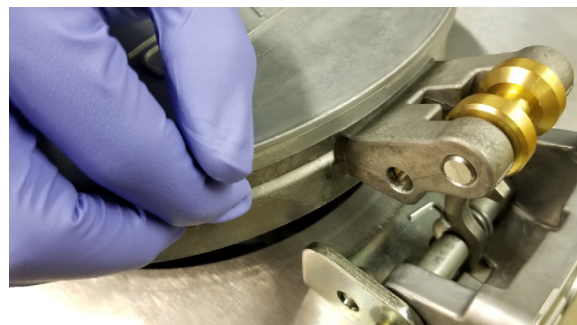
Step 1: Remove the Retain Pin from the Safety Pin

Step 2: Remove the Safety Pin from the Latch

Step 3: Unlatch the Latch. Note - The Safety Pin can be inserted into one of the two holes on top of the Latch to apply leverage to assist with Latching and Unlatching the Fill Opening

Step 4: Pull back the Secondary Latch Hook and lift the Fill Opening

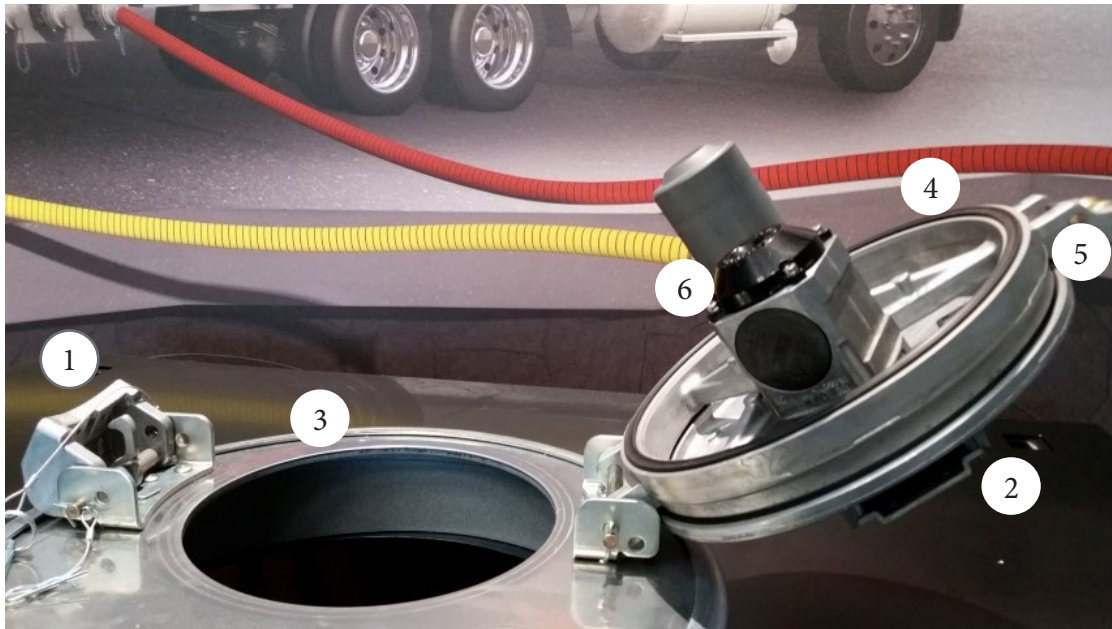
1.	Pull Safety Pin and unlatch the Latch.
2.	Open the Fill Opening.
3.	Inspect Sealing Surface of the base cover for signs of damage, or any other conditions that may impair sealing performance.

4.	Inspect the Frame Fill Opening Gasket for signs of damage, wear, or any other conditions that may impair sealing performance.
5.	Inspect Cover Poppet Gasket for signs of damage, wear, or any other conditions that may impair sealing performance. NOTE: Removal of Poppet may be required to fully inspect. See Section III Product Maintenance – for 7700N Series PAF Vent Disassembly Procedures.

6.	Inspect Normal Vent assembly for cleanliness and gasket integrity.

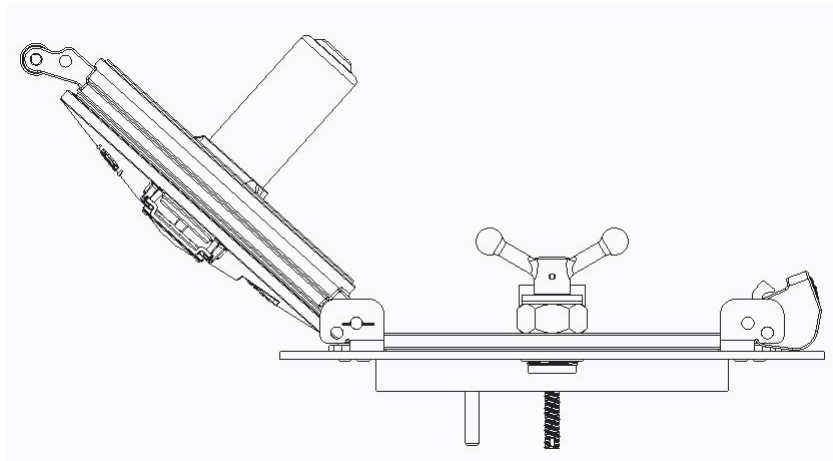
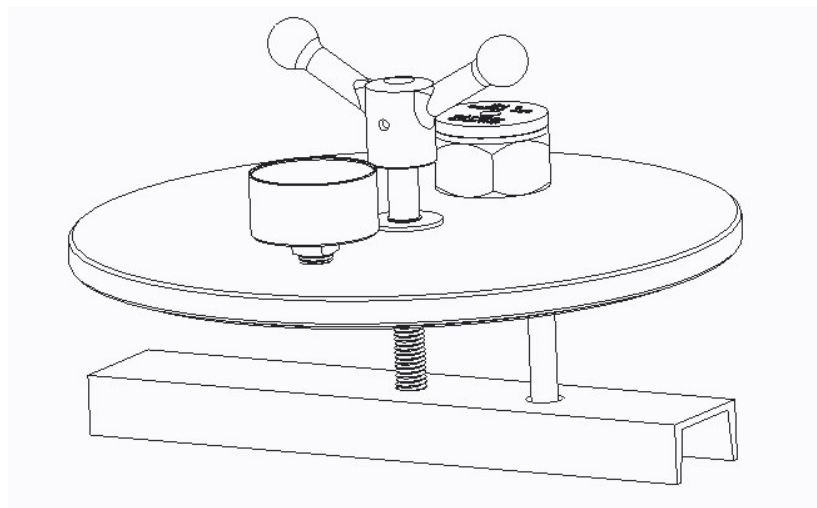
Figure 1

Civacon PN 13177 - ALVN Manlid Retest Fixture

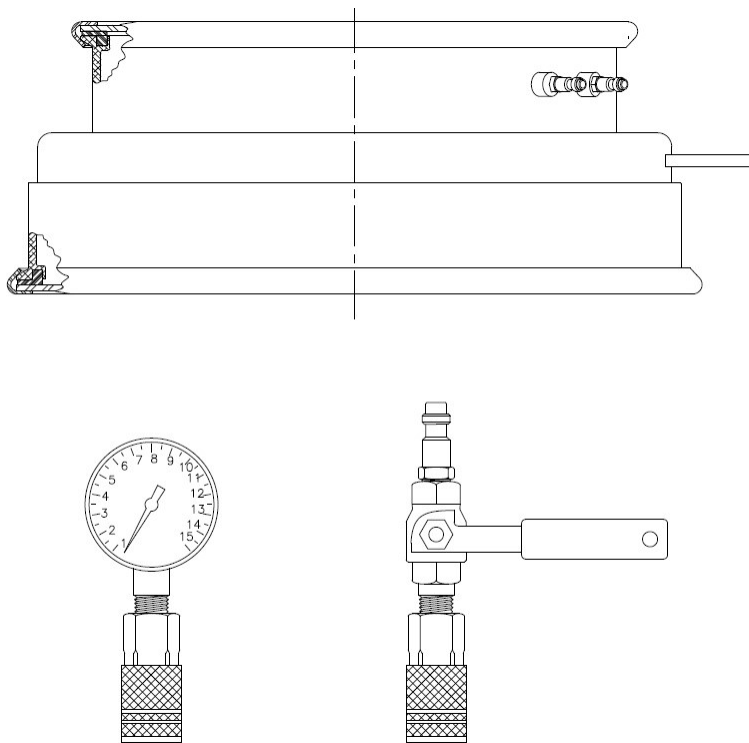
Figure 2

Civacon PN 5428A - Bench Test Fixture

3.	Attach the Manhole Assembly to an appropriate Bench Pressure Test Fixture such as Civacon Bench Test Fixture P/N 5428A. See Fig. 2
4.	Gradually apply pressure to the tank and observe the pressure gauge for point of relieving pressure. Per 49CFR178.346-3(c) the set pressure must not be less than 3.63 psig and not more than 4.55 psig for a tank with a MAWP of 3.3 psig.

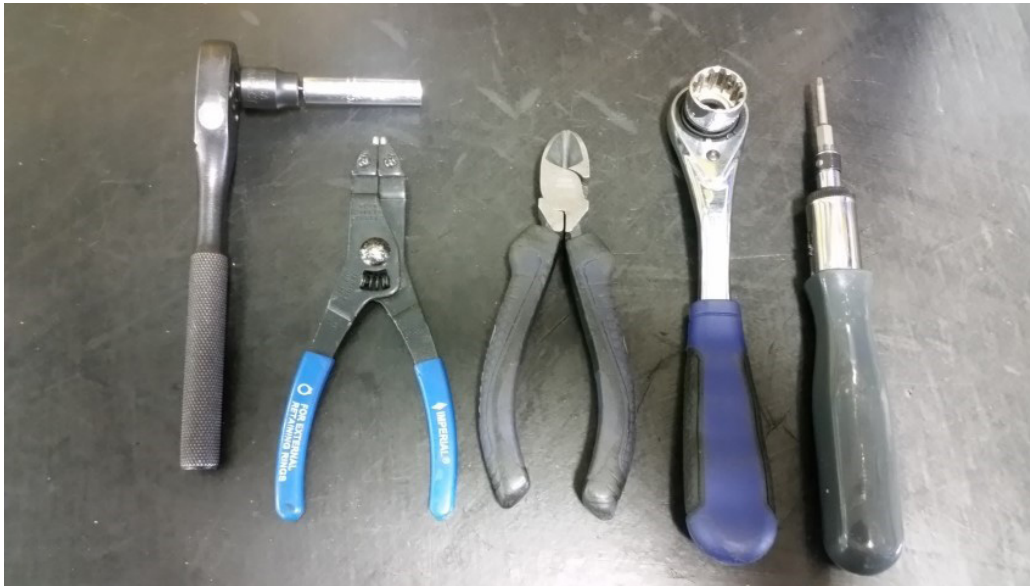
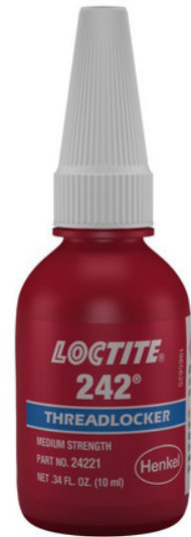
1. 1/4" Drive Ratchet Wrench with 5/16" Deep Well Socket
2. Snap Ring Pliers
3. Dikes or Needle Nose Pliers
4. Pass Through Type Ratchet Wrench with 11/16" Socket
5. Driver with T-10 Bit
6. Loctite Brand 242 (Blue) Thread Locker

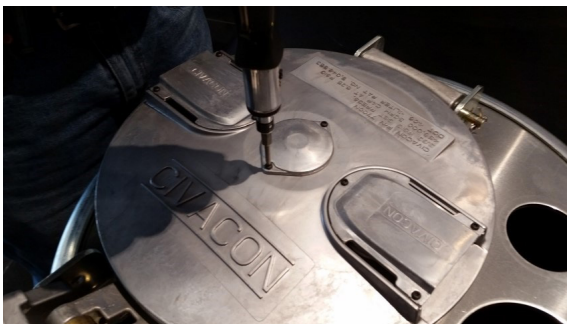
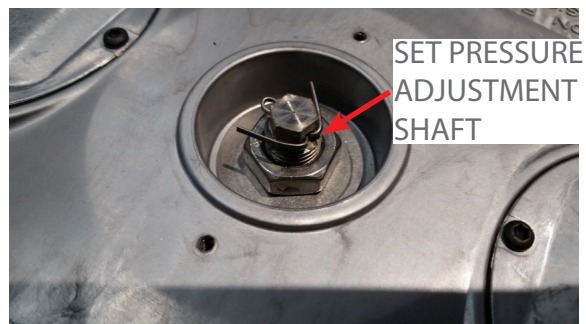
2. Remove two screws (11) from the set pressure adjustment access hatch (6) using a T-10 bit and drive and remove adjustment access hatch (6)
3. Remove cotter pin (16) from the motion control (8) set pressure adjustment shaft.

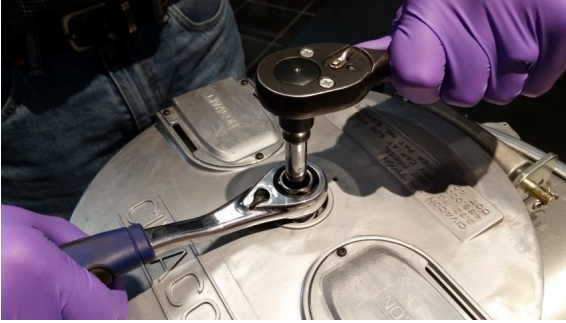
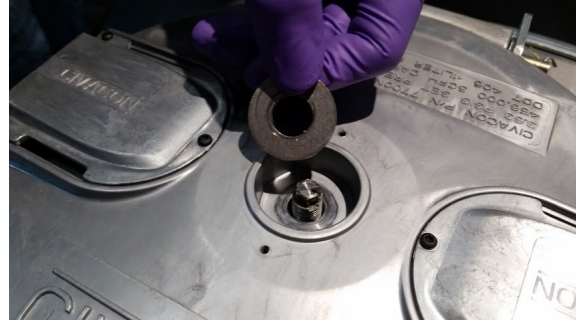
| 4. | <p>Using the pass through type ratchet wrench with 11/16" socket along with the ratchet with 5/16" deep well socket, remove nut (13) from the motion control (8) set pressure adjustment shaft. Use the ratchet with 5/16" deep well socket to keep the set pressure adjustment shaft from spinning while loosening the nut with the pass through type ratchet wrench with 11/16" socket.</p> <p>THE SET PRESSURE ADJUSTMENT SHAFT MUST NOT SPIN DURING NUT LOOSENING.</p> |
| 5. | <p>Remove washer (12) from the motion control (8) adjustment shaft.</p> |

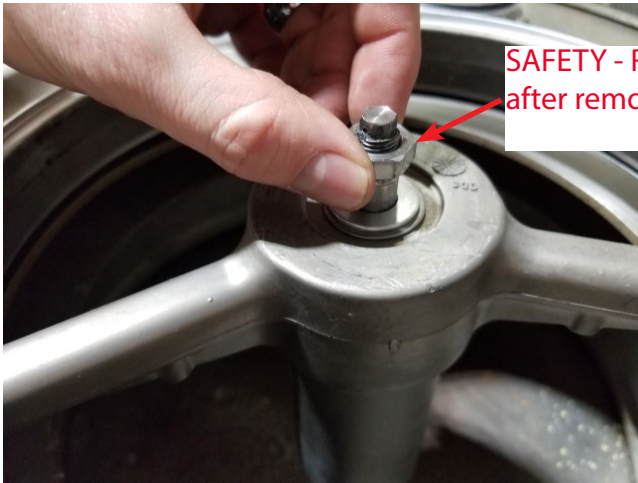
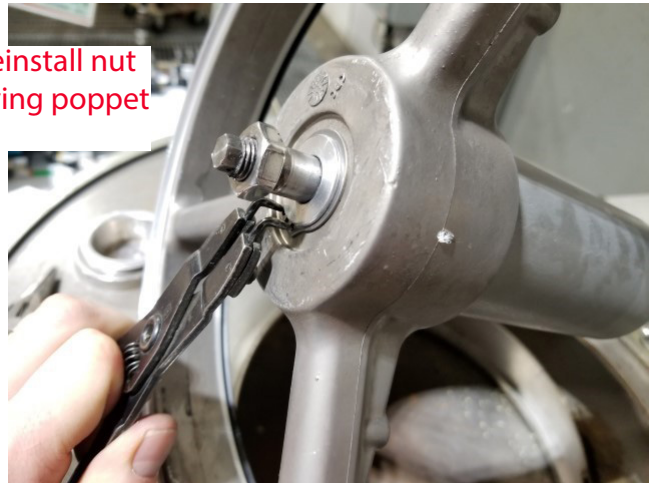
| 6. | <p>Remove cover poppet (3) from the motion control (8) set pressure adjustment shaft.</p> |
| 7. | <p>SAFETY STEP: Reinstall nut (13) onto the motion control (8) set pressure alignment shaft before removing from the frame as a safety precaution. Reinstalling this nut is to prevent possible injury due to motion control housing compressed spring retain failure.</p> |
| 8. | <p>Remove retaining ring (9) that is securing the motion control (8) to the frame(4).</p> |

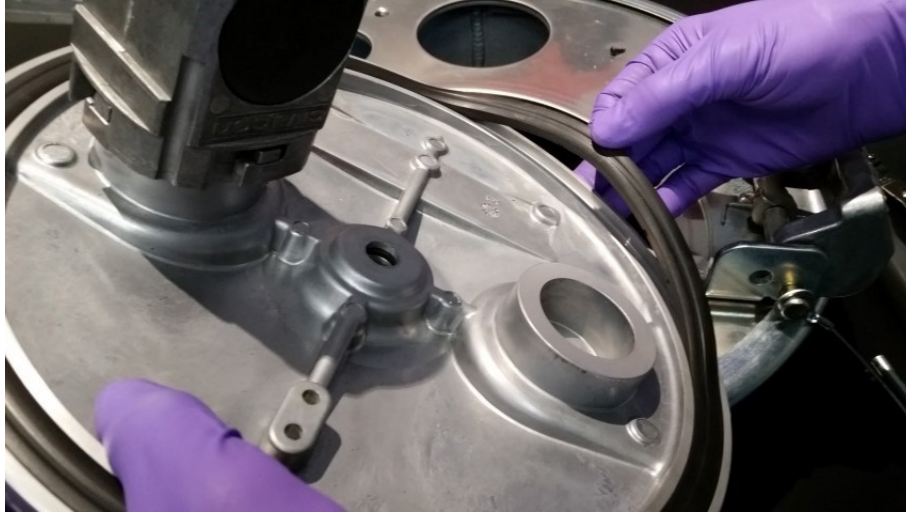
| 9. | Remove normal vent from cover poppet (3) using slip joint pliers. |
| 10. | Remove poppet gasket (2) from cover poppet (3) using care to not scratch internal sealing surfaces of the gasket groove. |

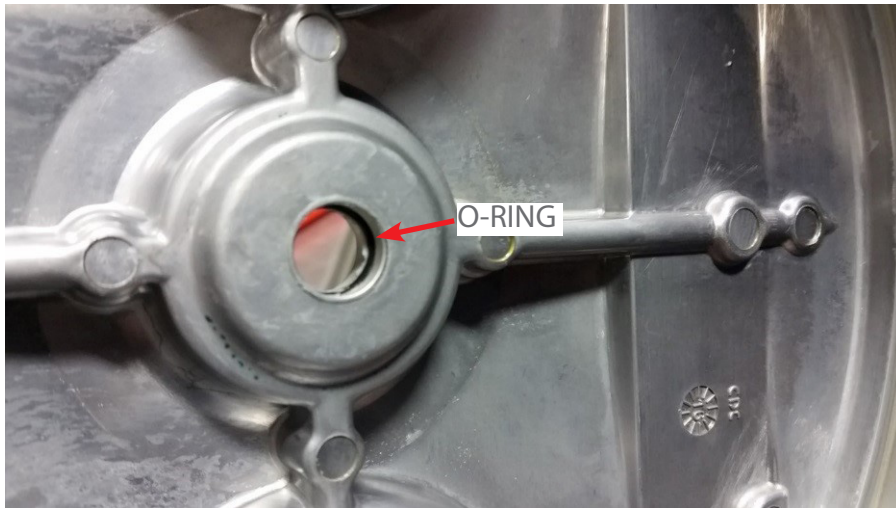
| 11. | Remove o-ring seal (7) from center bore hole of cover poppet (3) using care to not scratch internal sealing surfaces of the o-ring groove. |

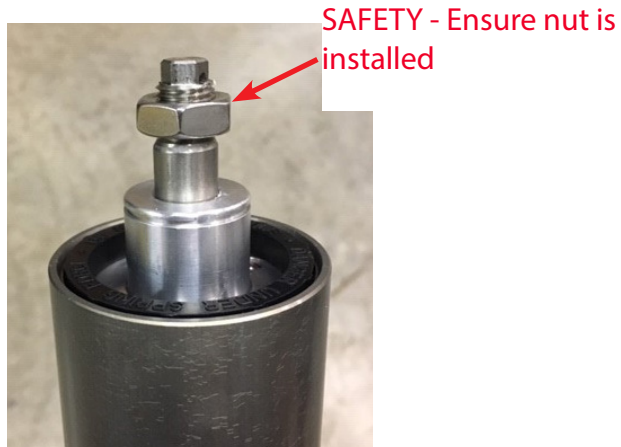
12. Remove motion control (8) from frame (4).

THE MOTION CONTROL IS NON SERVICEABLE - DO NOT DISASSEMBLE - CONTAINS COMPRESSED SPRING THAT CAN CAUSE INJURY IF DISASSEMBLY IS ATTEMPTED. **DISCARD AND REPLACE ONLY**

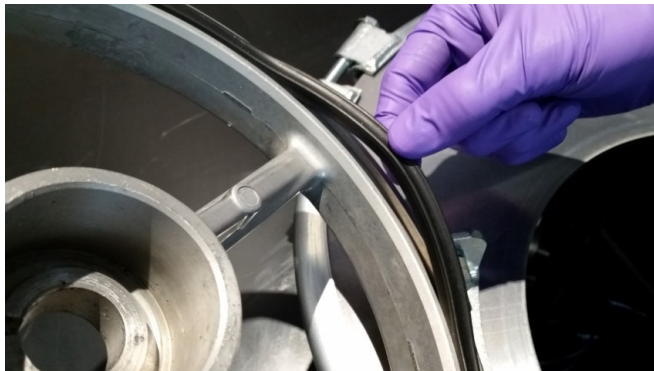
13. Remove the frame fill opening gasket (15) from the frame (4) using care to not scratch internal sealing surfaces of the gasket groove.

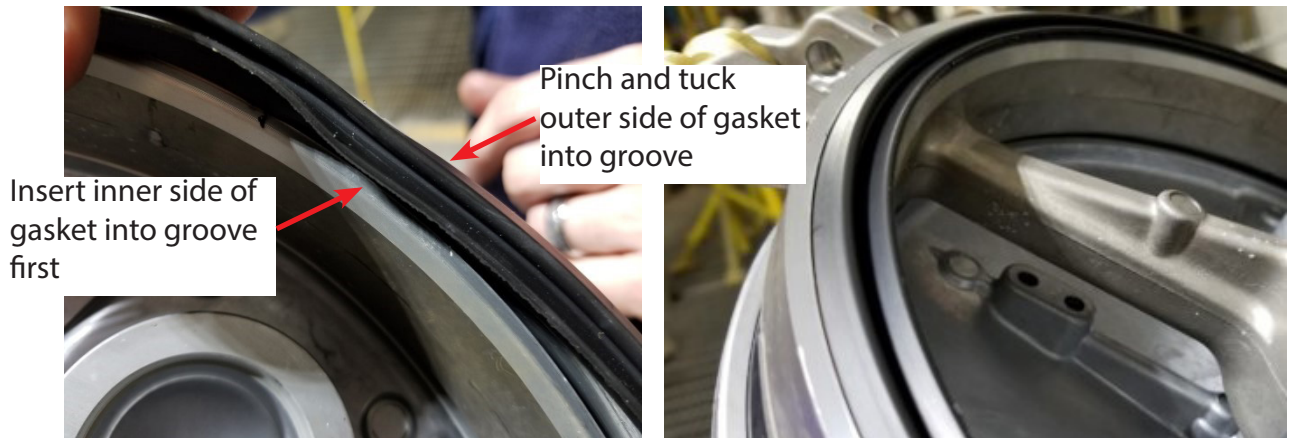
1. Install frame fill opening gasket (15) by hand into the frame (4). Pinch and tuck gasket into the gasket groove all around until entire gasket is completely installed.

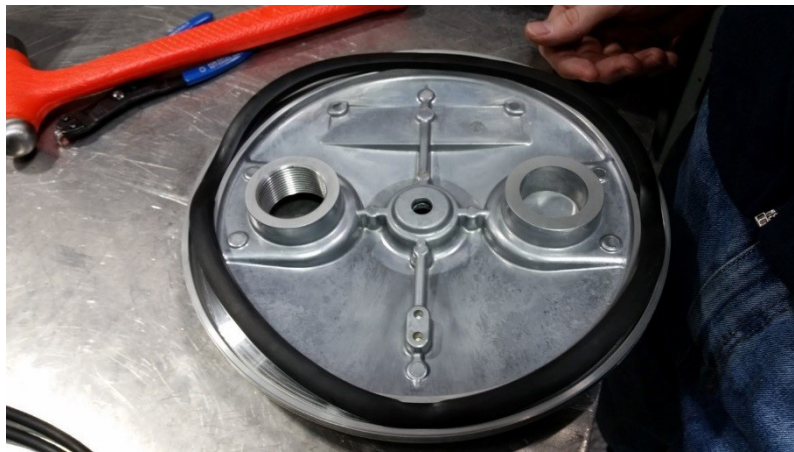
2. Install poppet gasket (2) by hand into the cover poppet (3). Pinch and tuck gasket into the gasket groove all around until entire gasket is completely installed.

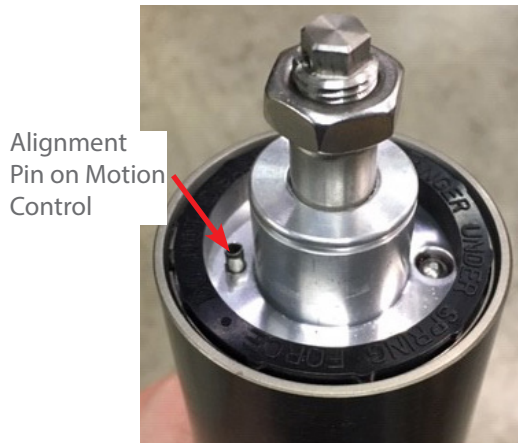
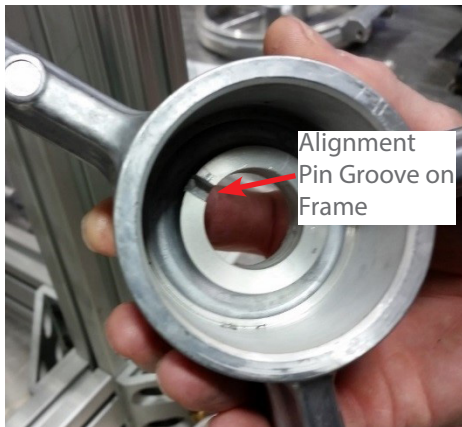
3. Install motion control (8) into the frame (4). The motion control alignment pin needs to align with the alignment pin groove in the frame for the motion control to become fully seated.

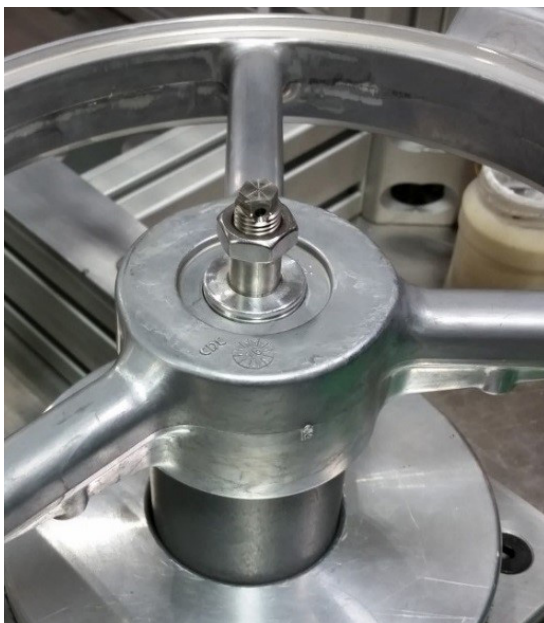
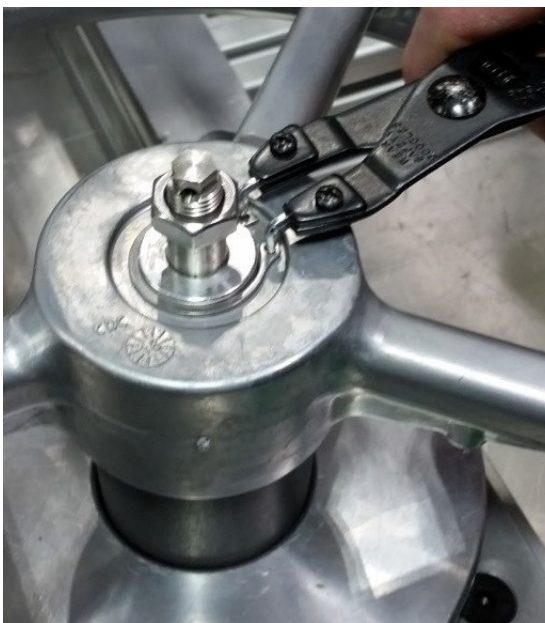
4. Install retaining ring (9) into the motion control (8) retain ring groove to secure it into the frame (4).
5. Remove nut (13) from the motion control (8) set pressure alignment shaft and set aside for step 9.

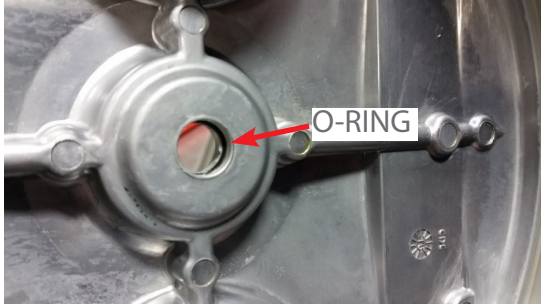
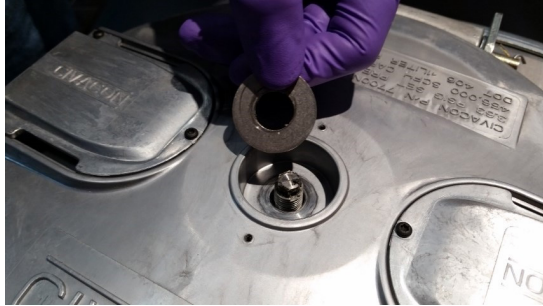
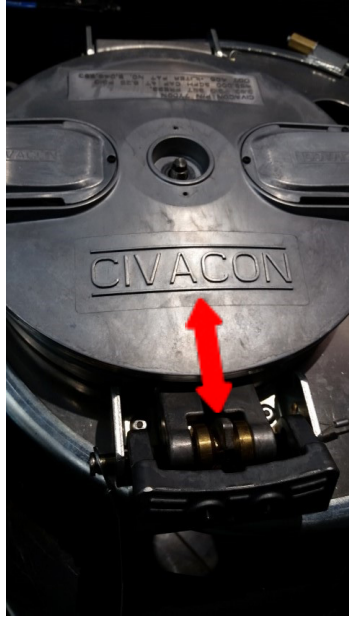
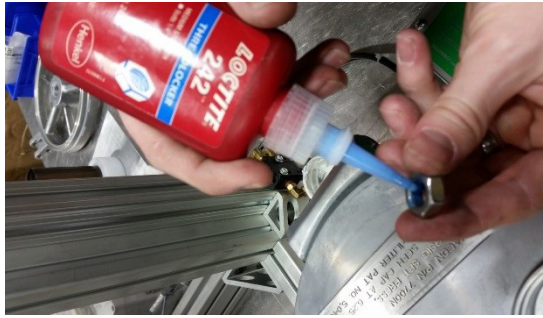
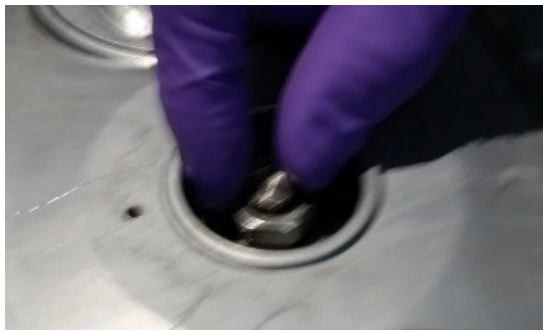
6.	Install o-ring seal (7) into center bore hole of cover poppet (3).
7.	Install cover poppet (3) onto the motion control (8) set pressure adjustment shaft. CIVACON LOGO ALIGNED WITH THE LATCH ROLLER.
8.	Install washer (12) onto the motion control (8) set pressure adjustment shaft.
9.	Apply Loctite Blue 242 to threads of nut (13).
10.	Install nut (13) onto the motion control (8) set pressure adjustment shaft and hand thread down until the flats of the 5/16" hex on the motion control set pressure adjustment shaft are accessible for a 5/16" deep well socket.

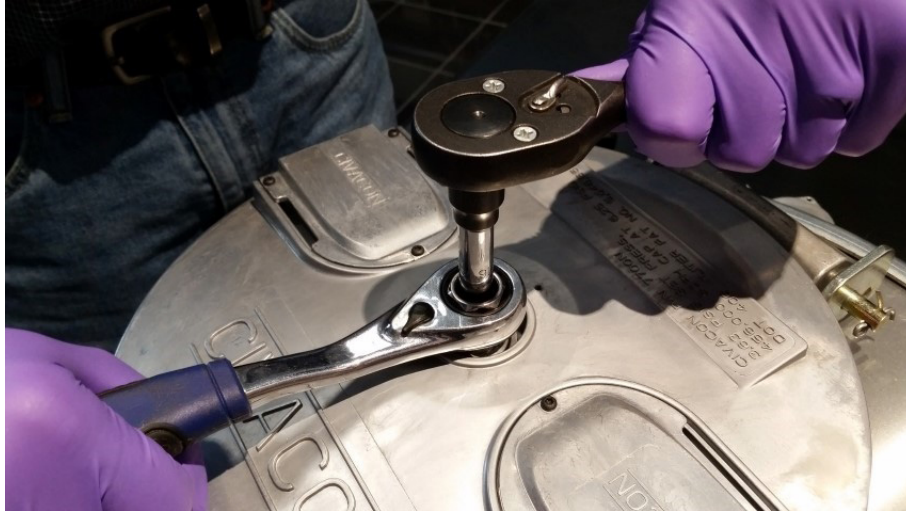
11. Using the pass through type ratchet wrench with 11/16" socket along with the ratchet with 5/16" deep well socket, tighten nut (13) onto the motion control (8) adjustment shaft. Use the ratchet with 5/16" deep well socket to keep the set pressure adjustment shaft from spinning while tightening the nut with the pass through type ratchet wrench with 11/16" socket. Nut (13) should be snug tightened.

THE SET PRESSURE ADJUSTMENT SHAFT MUST NOT SPIN DURING NUT TIGHTENING.

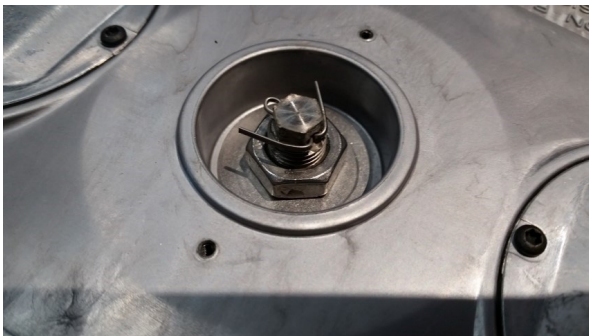
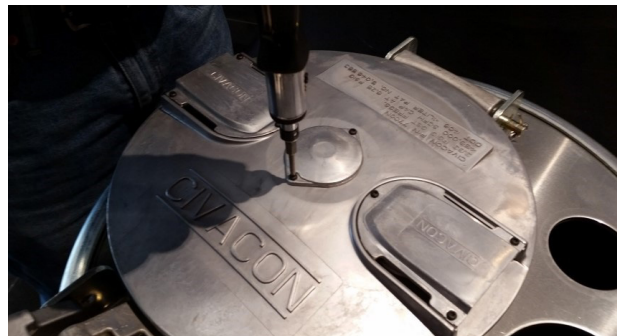
12. Install cotter pin (16) into the motion control (8) set pressure adjustment shaft.
13. Install the set pressure adjustment access hatch (6) on to the cover poppet (3). Secure in place with two screws (11) using a T-10 bit and drive.

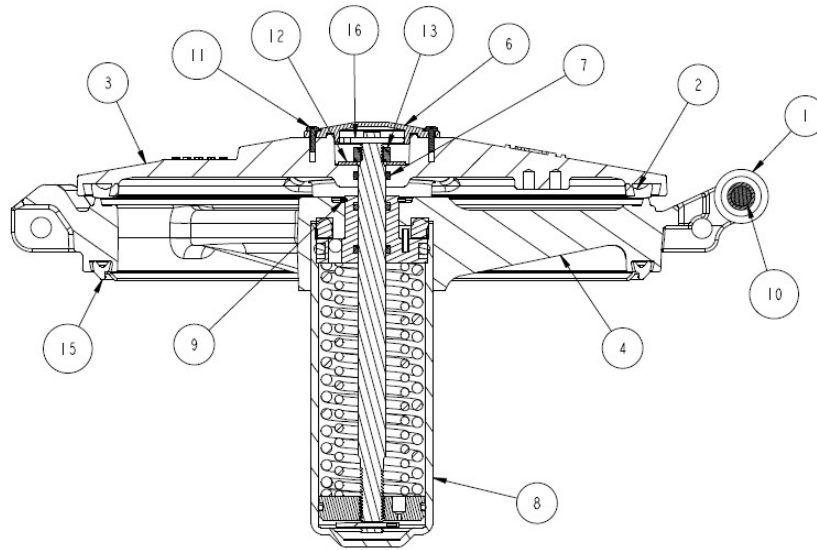
7700N Series PAF Vent

1.	11730	Latch Roller
2.	12022	Poppet Gasket (Buna-N or Viton) PN Shown for Buna-N Gskt
3.	12834	Cover Poppet
4.	12836	Frame
6.	13007	Set Pressure Adjustment Access Hatch
7.	13018	O-Ring 2-112 Viton
8.	13020	Motion Control
9.	13021	External Retaining Ring
10.	13025	Roller Pin
11.	13149	Screw, 4-40 x 3/8 Thread Forming
12.	11693	Washer
13.	13031	Nut, 7/16-20
15.	13226	Frame Fill Opening Gasket
16.	13274	Cotter Pin

Reference Page 19 Assembly Drawing

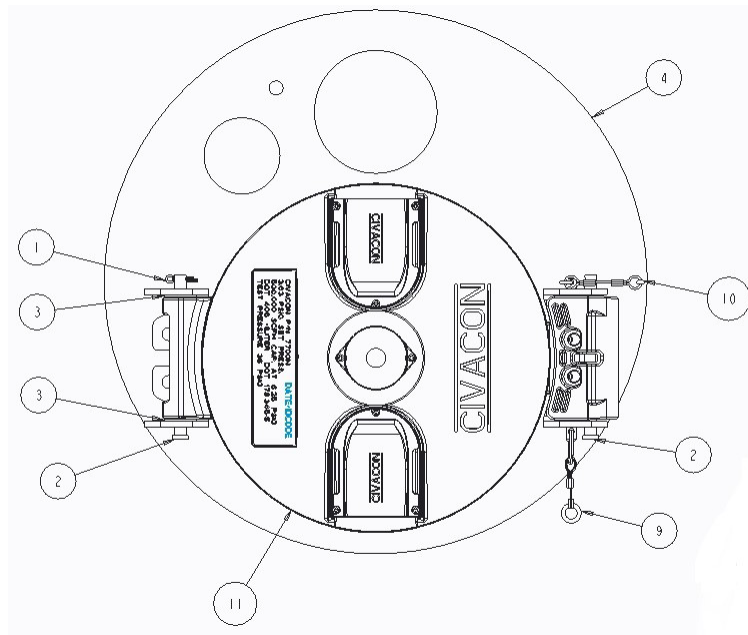
ALVN Manhole Cover

1.	1045	Cotter Pin
2.	5951	Clevis Pin
3.	11693	Washer
4.	7700N	Cover Assembly
9.	13033	Latch Safety Pin
10.	13035	Retain Pin
11.	NV4000	PAF Vent

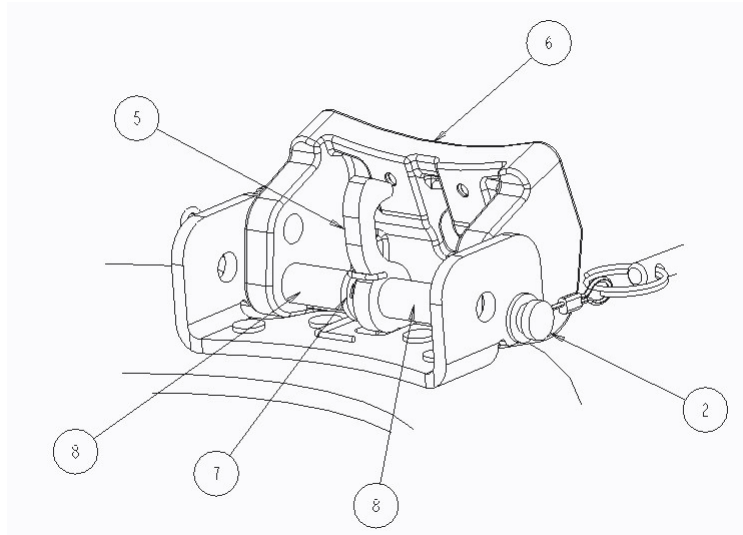
ALVN Manhole Cover Latch

2.	5951	Clevis Pin
5.	12825	Secondary Latch Hook Catch
6.	12838	Latch
7.	12946	Torsion Spring
8.	13024	Spacer

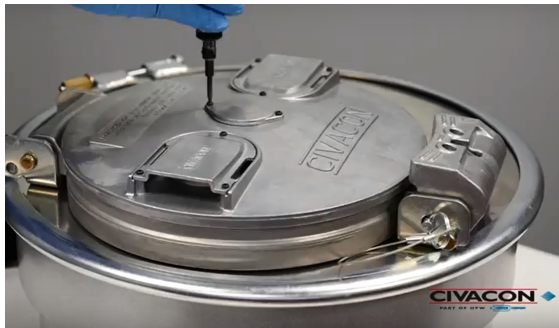
Step 1:

Remove two screws from pressure setting adjustment access hatch using a T-10 bit and drive.

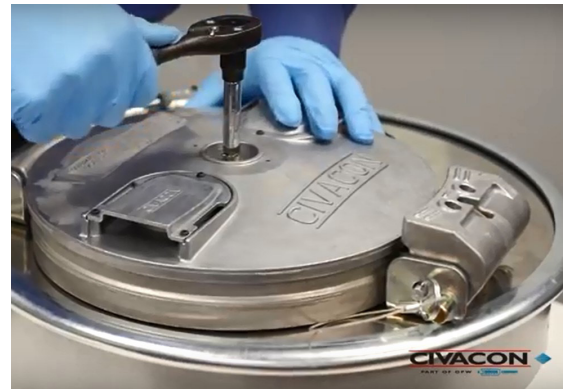
Step 2:

Using 5/16 socket and drive, rotate the shaft clockwise to increase set pressure or counter clockwise to decrease set pressure. Rotate one 360° revolution of the shaft then pressure test. Repeat until desired pressure setting is achieved.

NOTE: Nut rotates with the shaft.
