# **TEST REPORT**

# OPW 36 Composite Cover BS EN124 C250 Test

Document reference number - FIB-OPW36-C250-12-04-18

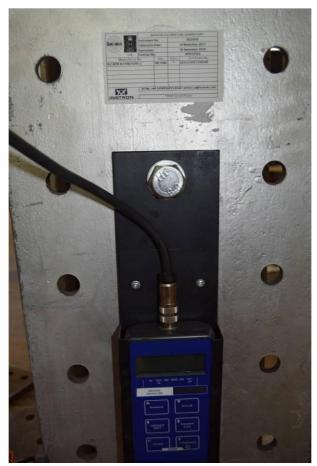
Photo.3

Photograph 3 below shows the calibration certificate for the load cell and test rig.

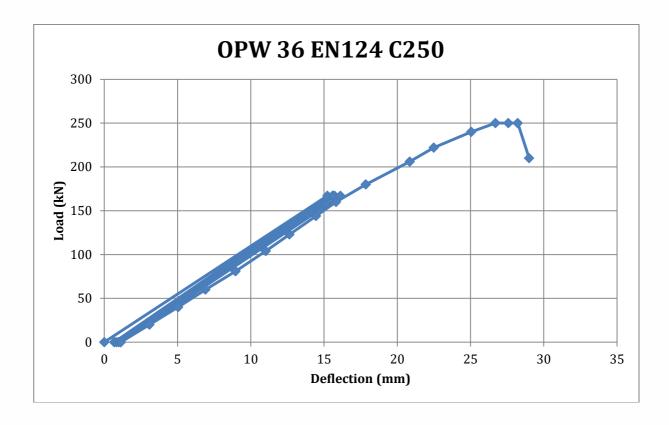
LOAD (kN)	DEFLECTION (mm)	REMARKS
0	0.00	
167	15.23	
0	0.68	
167	15.58	
0	0.83	
167	15.61	
0	0.98	
167	15.72	
0	1.12	
167	16.12	
0	1.12	
20	3.08	
40	5.04	
60	6.90	
81	8.96	
104	11.02	
123	12.64	
144	14.45	
160	15.82	
180	17.85	
206	20.85	
222	22.49	
240	22.05	
250	26.70	
250 (10 seconds)	27.58	
250 (20 seconds)	28.22	
250 (30 seconds)	30.62	PASS

The cover held the test load of 250kN for the required 30 seconds so therefore passed the load Bearing test.

The slight difference noted between the true permanent set reading taken on the top face and that of the zero readings taken on the underside, can be explained by the fact that the underside readings show the result of the cover bedding into the frame.
