TEST REPORT

OPW 41 Composite Cover BS EN124 C250 Test

Document reference number - FIB-OPW41-C250-13-06-19

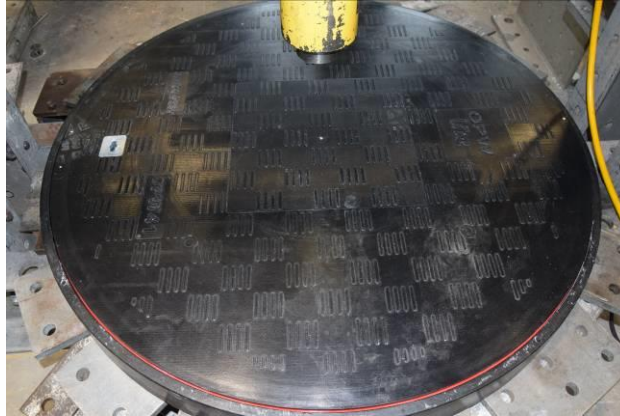
Photo. 1

The composite cover supplied is a round OPW 41 complete with a composite frame. (Photo.1)

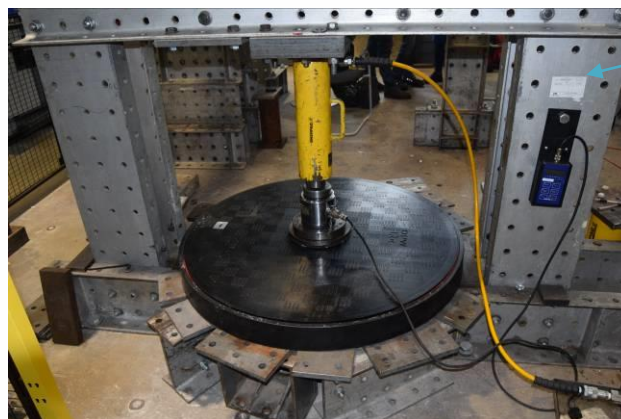
Photo.2

The test rig consists of a 'giant mecano' frame bolted to the floor and supporting the Enerpac 50 ton hydraulic cylinder. (Photo.2)

The cover was seated on steel channels with steel plates and shims to pack and level.

In accordance with the EN124-1:2015 standard the load cell and test rig complies with EN ISO 7500-1:2004 minimum Class 3.

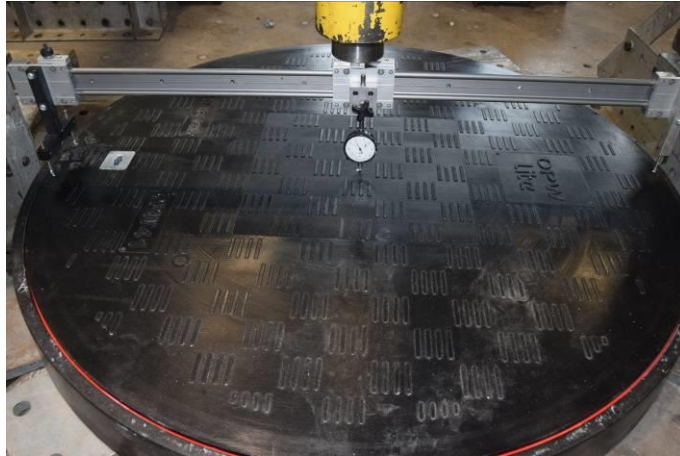
Photo.4

Initial Reading	0.00mm
Reading after 5 cycles	0.62mm
Permanent Set	0.62mm

Permissible permanent set for a C250 test is $\frac{CO}{300} = 1025/300 = 3.41\text{mm}$

Therefore cover passes the permanent set test.

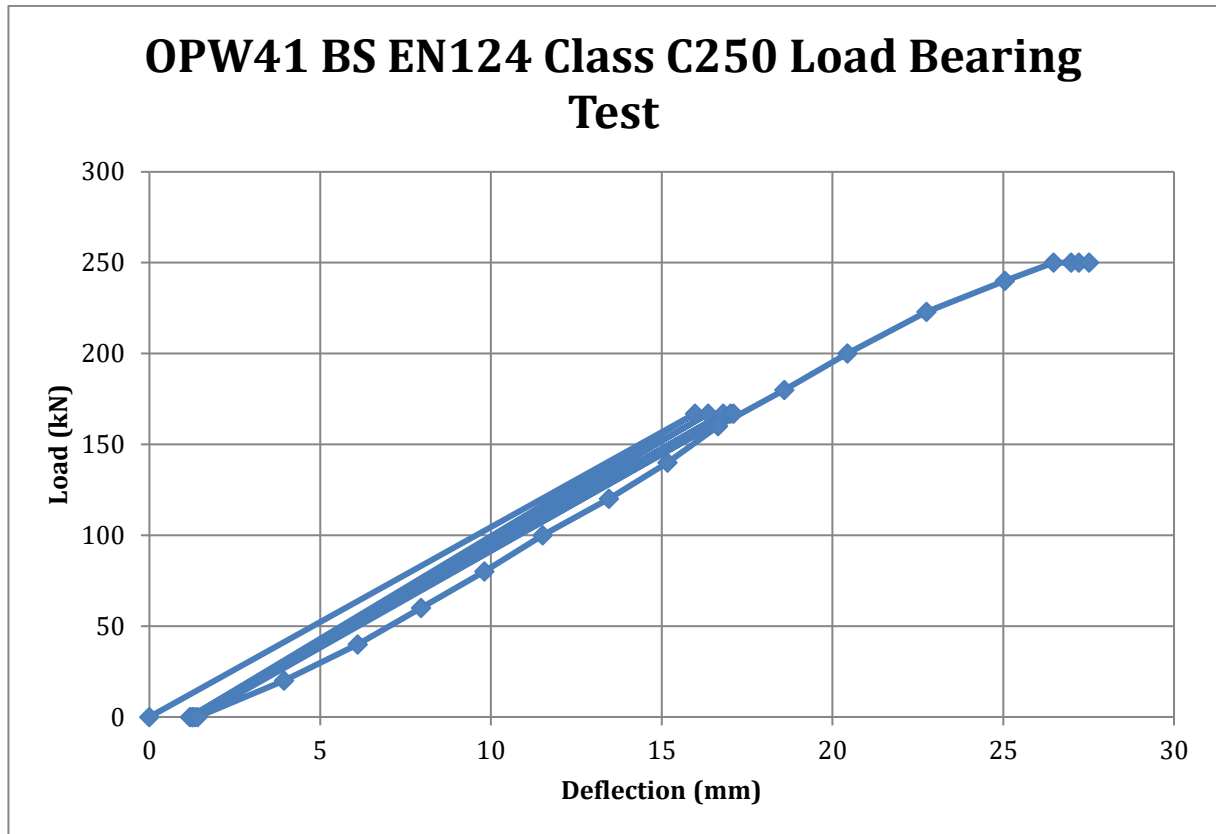
The cover held the test load of 250kN for the required 30 seconds with no visible signs of damage so therefore passed the BS EN 124 C250 Load Bearing test.

The slight difference noted between the true permanent set reading taken on the top face and that of the zero readings taken on the underside, can be explained by the fact that the underside readings show the result of the cover bedding into the frame.

There were no signs of any visible damage to the frame.
